Manhole Inspection Summary

Manhole # S39EE_010MH

Insp Date: **1/14/08 1:39 PM**

Location Address: **1204 AISQUITH ST**

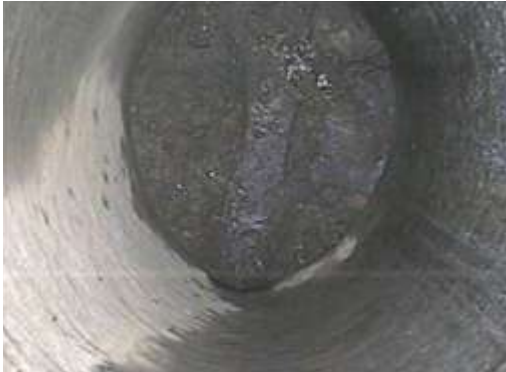
Defect 1

Count: **4** Missing: **3** ☒ **Corroded**

☒ **Evidence Of Surcharge** Depth: **1** (ft.) ☐ Active Surcharge Present

evidence surcharge;missing step

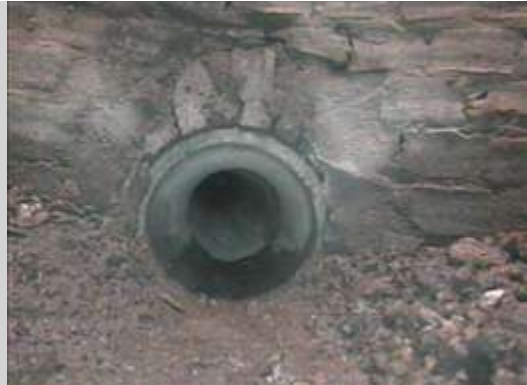
12 O'Clock Outflow

8 in. Circular Gravity Sewer
Pipe Out @ 12 O'Clock

Deposits: ☐ None ☐ Mud ☐ Sludge ☒ **Debris** ☐ Grease

Silt Depth: **2** (in.) Deposits Extent: **Light**
